River Rhee Invasive Plants and Water Vole Survey

Section 1

Spring 2013

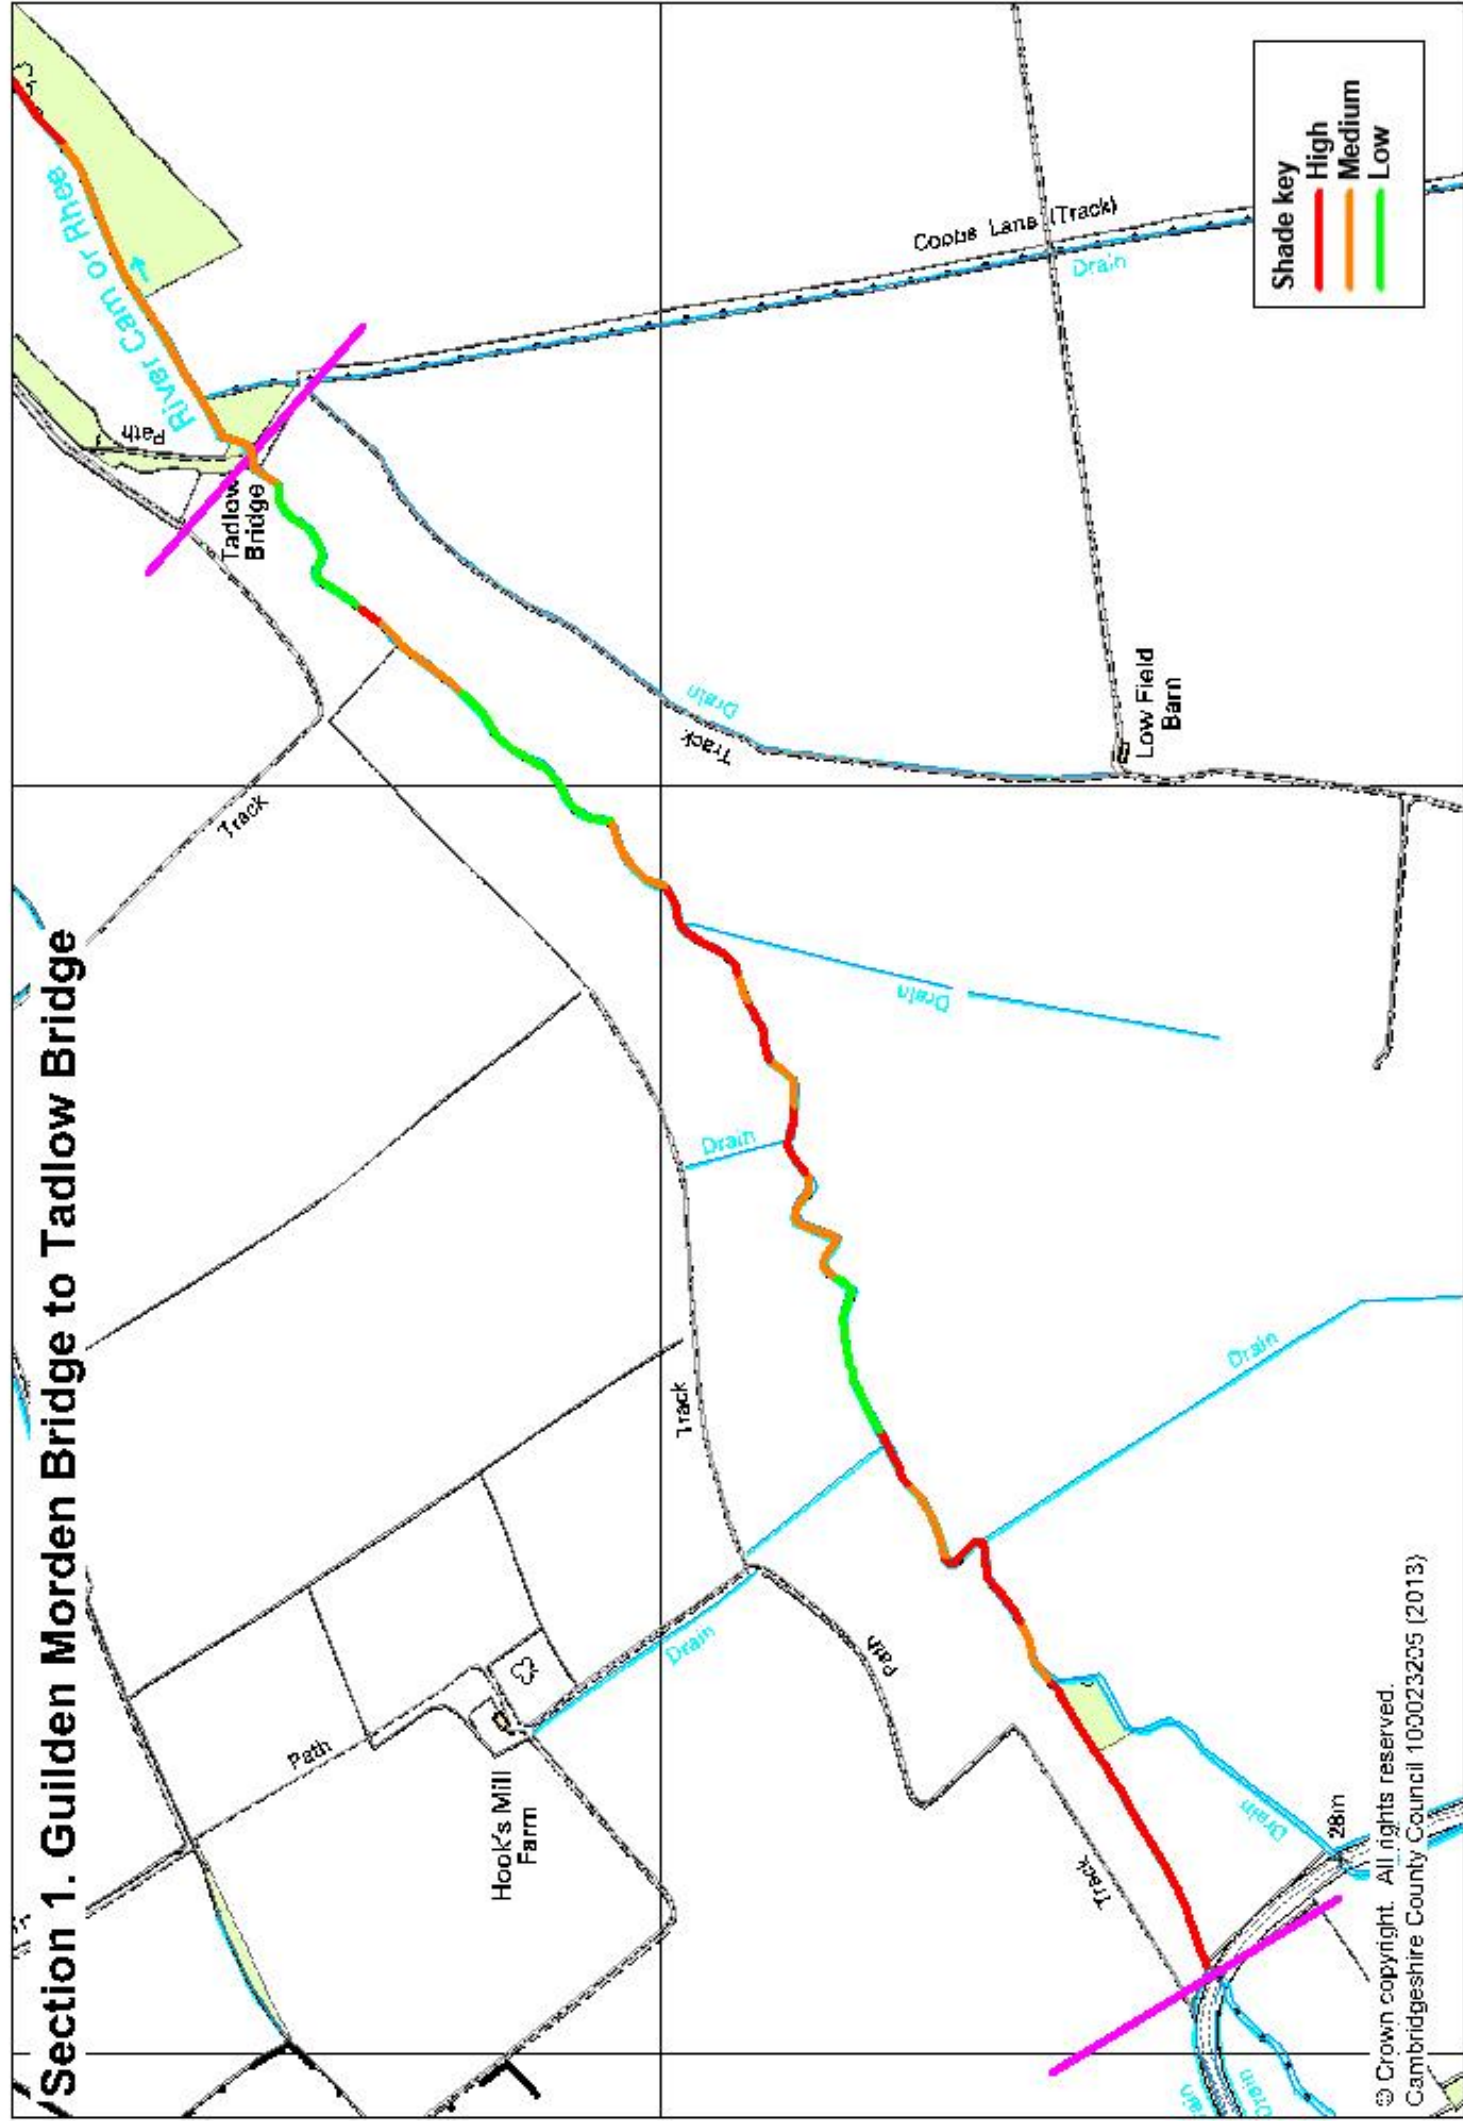
Section 1. Guilden Morden Bridge to Tadlow Bridge

The section runs from Guilden Morden road to Tadlow Bridge. Bank height varies from 1.5 to 2.5m. The right bank is mostly very steep, around 60°; the left bank is generally shallower (closer to 30°). Channel width is 1.5-2m; average depth approx 0.5m. At the downstream end, the river bed is firm with some gravel visible (although the water was turbid at the time of survey).

The upstream third of this stretch is very shady, with tree cover along both banks until a small ash plantation. The channel is relatively uniform but there are small weirs created by woody debris. The downstream section is much more open and provides good water vole habitat. There is also more in-stream diversity here, created by small bank slips, vegetated silt bars, woody debris and vegetation in the channel. Channel vegetation includes branched bur-reed and reed canary grass with clumps of water starwort, lesser water parsnip and water crowfoot (present near Tadlow Bridge). A huge badger sett narrows the channel to 1m at one point. At several other locations (usually on bends) the bank is steep and eroding.

Water voles: One water vole was seen, plus 4 feeding signs and several holes and runs. It is very likely there were more signs which could not be

Invasive plants: None recorded.

Shade: Heavily shaded at the upstream end, becoming much more patchy and open downstream.

Comments and recommendations: This section has good habitat, with a variety of shade, vegetation and in-channel features. The field margins provide a valuable extension of water vole cover, which may help them elude mink. It may be that water voles are using the field margin rather than leaving many signs at the water's edge.

- Maintain generous field margins and long grass on river banks; prevent trees and scrub from spreading along the banks.
- Bank stabilisation where erosion is taking place would reduce the sediment input to the river.

- There may be opportunities to enhance the habitat in the gravelly ditch (would need to know the flow variation) and to create a fish refuge near where it joins the river.

- Improvements to the wastewater treatment works could reduce pollution events.
- Pollarding willows lengthens their life and helps provide valuable habitat for invertebrates. Some of the older willows here could be pollarded, although this would entail a landowner commitment to re-pollard in 10-15 years.

- Low weirs created by pieces of wood wedged in the channel give the river energy and improve oxygenation. Some of these have formed naturally but more could be installed.

- Some of the in-stream woody debris could be fixed more securely in place. Providing it remains at a low level it should not impede flood water but provides refuge for fish and invertebrates as well as flow diversity.

- The outflow from Hook's Mill was holding water at the time of survey, but was dry at the point where it meets the river (with its bed level 1 – 1.5m above river water level). This channel could be expanded to create a back channel or there may be a way to improve flow through the mill (not surveyed).
